MEYER

UTILITY STRUCTURES

Achieving Weld Performance Excellence

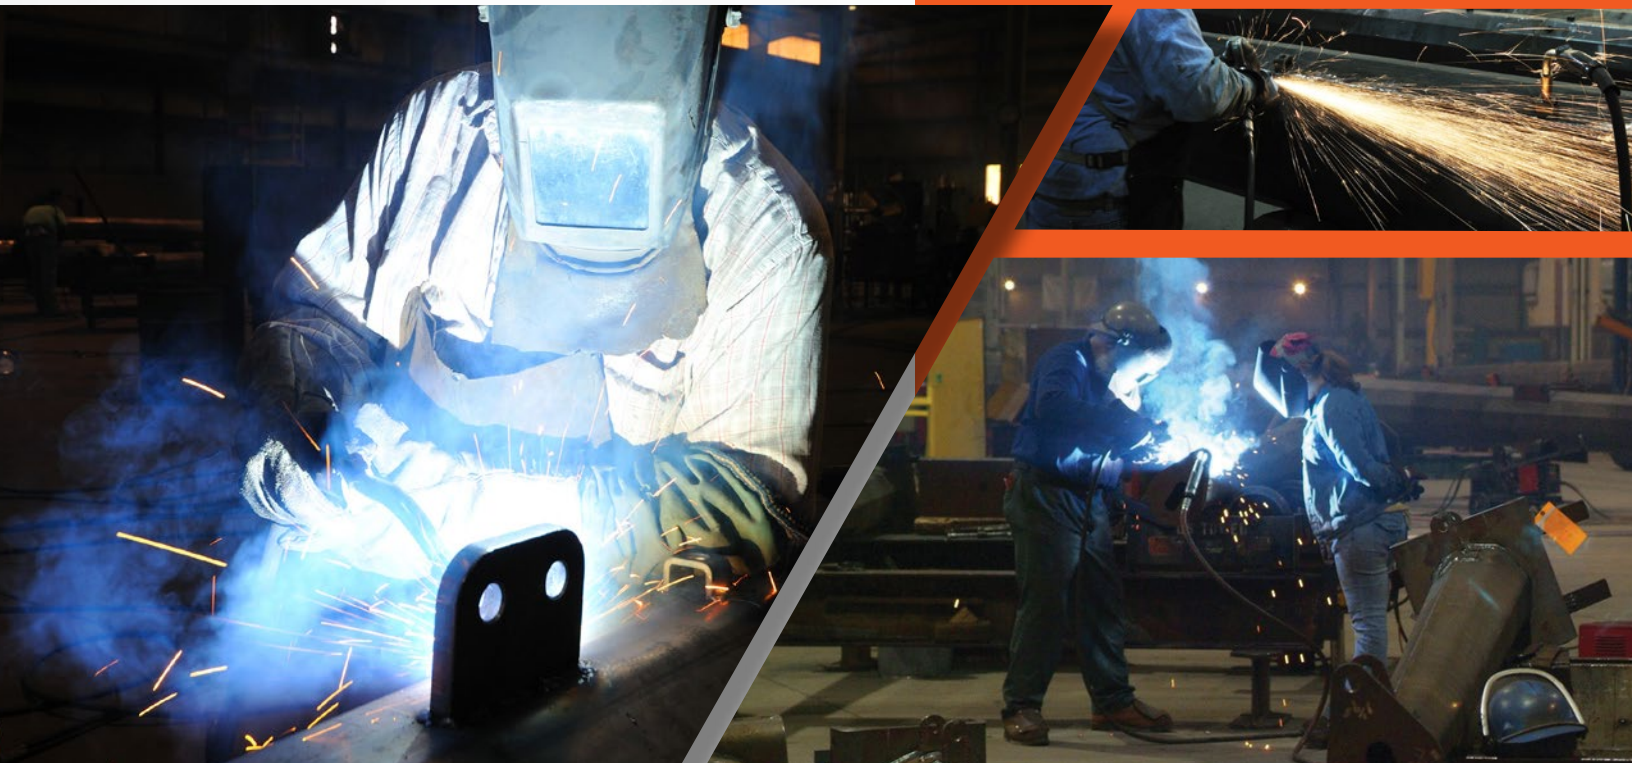
Meyer performs 100% ultrasonic inspections on all full penetration welds as required by ASCE 48-11.

All full penetration welds require 100% ultrasonic inspection or radiographic inspection (AWS D1.1)

All full penetration baseplate and flange plate welds shall be 100% UT inspected for toe cracks both before and after galvanizing (ASCE 48-11)

Per ASCE 48-11, Section 10.3.5, all full penetration welds shall be 100% ultrasonic inspected for toe cracks after galvanizing. "Toe cracks" can be caused by several factors of the fabrication process, including welding practices, material characteristics, and product designs. Toe cracks are oftentimes formed on baseplate welds when varying baseplate and pole shaft material thicknesses cool at different rates. Because thicker baseplate materials cool more slowly, additional stresses are applied to the connecting welds, creating toe cracks. Proper preheat and monitoring of minimum interpass temperatures can result in more consistent cooling rates, which will assist in prevention of toe cracks. Extreme heating events, such as galvanizing, may also create residual stresses on welds, further promoting toe cracking.

Meyer performs 100% ultrasonic inspections on all full penetration welds as required by ASCE 48-11. Thorough visual inspections are also conducted by certified welders and weld inspectors to detect any cracking or any other undesirable characteristics.

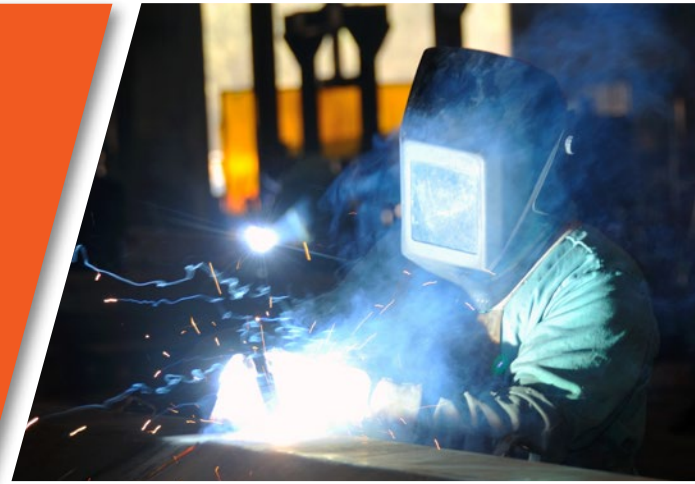
Wind Induced Vibration

Wind induced vibration is caused by alternating wind vortices flowing over a surface. When steady state wind passes across a slender structural member, such as a conductor or an overhead shield wire arm, the resulting vibration generates cyclic loads that impose bending stresses at the highest stress locations or at points of weakness, typically the weld joint and heat affected zone of the structural member.

Studies have shown that full penetration welds are significantly more resistant to cyclical vibration loading. Meyer Utility Structures uses 100% full penetration welds on all arm bracket to arm shaft welds. Meyer has successfully completed testing on arm bracket to arm shaft connections to provide reliability and confidence in the integrity of these connections.

Fillet Weld
(others)

Partial Penetration Weld
(others)

Full Penetration Weld
(Meyer)

All welds are not created equal. Some welds are much more susceptible to failure than others. While fillet, partial, and full penetration welding practices are all used, full penetration welds with reinforcing fillet welds provide the greatest assurance against weld failure.
